# BELZONA FILLS PITTED AREAS AND COATS 54 INCH JET VALVE

ID: 5820

Pitted areas of a 54 inch jet valve need to be filled and coated

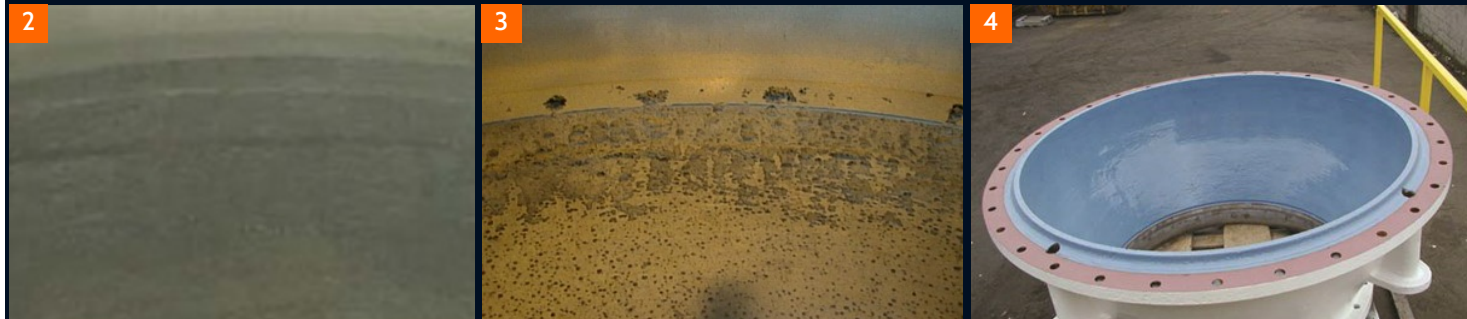
## PHOTOS

1. View of pitted shell
2. Pitting filled with Belzona 1111
3. View of valve prior to application
4. Completed application with Belzona 1341

The surface was prepared by blast cleaning to meet the minimum requirement of SA 2 1/2 or equivalent in accordance with ISO 8501-1. All edges or irregular protrusions were ground to a smooth contour and all dust, blast media and other debris were removed. All surfaces were degreased using a suitable cleaner-degreaser. The mixed Belzona 1111 was scrubbed into the pit in order to wet it out completely. Once wetted out, additional Belzona 1111 was applied to fill the pit and not just bridge over it. An applicator was used to contour Belzona 1111 to the shape of the vessel. Once cured, Belzona 1341 was applied at a thickness of 250-300 microns. The surface preparation for the valve was carried out as it was for the pitted areas. Belzona 1341 was then applied as a stripe coat and overcoated within the 24 hours overcoating window. The applied material was visually checked for pinholes to ensure proper application.
