# BELZONA PROTECTS HELLAN FLUID STRAINER FROM WASTE

ID: 5824

A Hellan fluid strainer at a Water Pollution Control Plant.

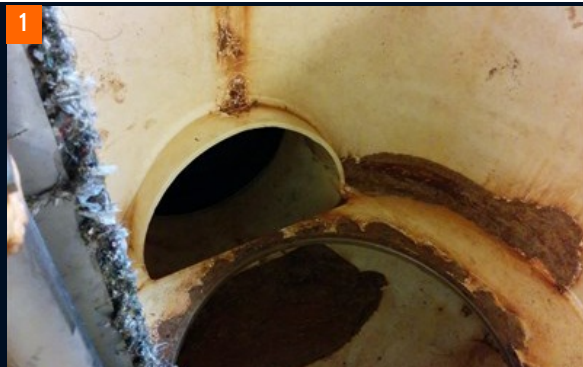
Erosion/Corrosion from the waste water.

1. Prior to application
2. Preparation of the surface
3. Completed application
4. Completed application

The application was carried out in accordance with Belzona Know-How System Leaflet CEP-5 for the repair of general erosion damage. The surface was blasted to prepare the area. Belzona 1212 was applied to build up any areas that were pitting. As a two coat system, Belzona 1331 was brush applied to the surface in accordance with Belzona Instructions For Use.
