# BELZONA PROTECTS NEW FLANGES AGAINST CORROSION

ID: 5826

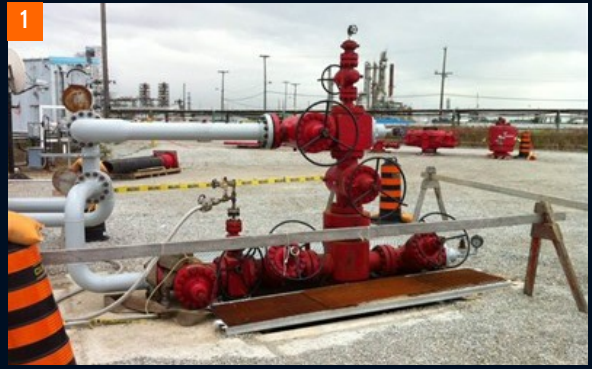
Previous flanges were suffering from corrosion. New flanges were installed and the customer wanted to avoid corrosion.

1. Prior to application
2. Completed application
3. Completed application

The application was carried out in accordance with Belzona Know-How System Leaflet GSS-11 for the protection of flanges and fastenings. The surface was cleaned and prepared using Belzona 9111 to remove all dirt, grease and surface contaminants. The surface where Belzona 3411 was bonded to was prepared using a wire brush. Belzona 9431 was applied to the flange, covering the gap. Belzona 8411 was spray applied to the surface and once touch dry, plastic caps were applied to the bolts of the flange. Two coats of Belzona 3411 were applied to the flanges in accordance with Belzona Instructions For Use.
