# BELZONA REPAIRS HOLE ON SCUM TANK

ID: 5827

Scum tank at a water pollution control plant.

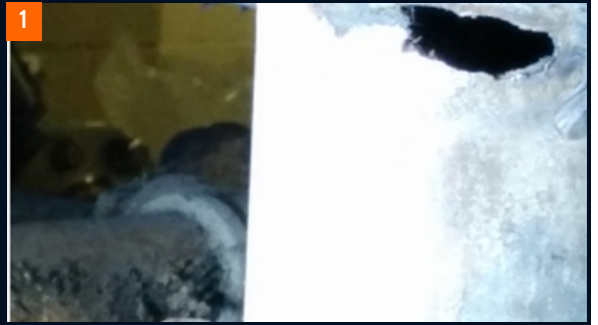
Hole caused by corrosion.

1. Prior to application
2. Preparation in progress
3. Application in progress
4. Completed application
