# OFFSHORE PRODUCTION DECK RESTORATION WITH BELZONA

ID: 5829

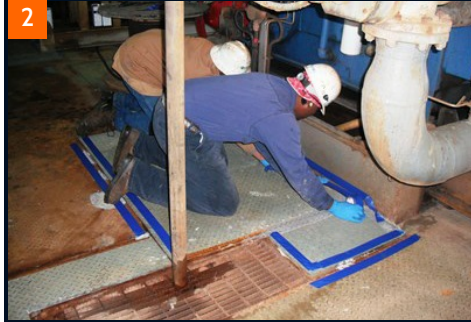
Years of service without adequate maintenance in the offshore environment caused severe corrosion/metal loss of the production deck, impacting the structural integrity and personnel safety.

1. Condition of deck before restoration.
2. Installation of plate bonding system.
3. Restoration of new plates complete.
4. Two coat system of Belzona 5811 applied to new deck plates.
