# CONVENIENT BELZONA CONVEYOR BELT REPAIR

ID: 583

Previously vulcanized joints in coal conveyor utilizing Tip Top.

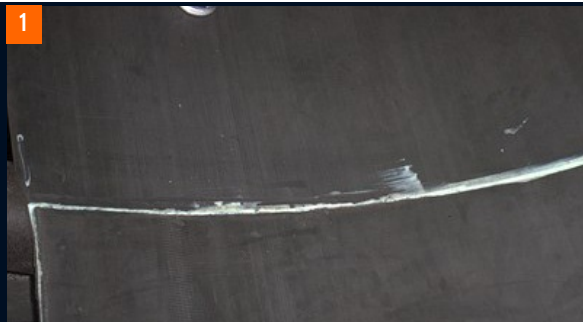
Joint failing due to moisture.

1. Original joint
2. Repair area masked off and conditioned
3. Completed application
