# BELZONA REPAIRS FLOOR CRACKS CAUSED BY A ZAMBONI

ID: 5837

Floor leading to rink access used by a Zamboni.

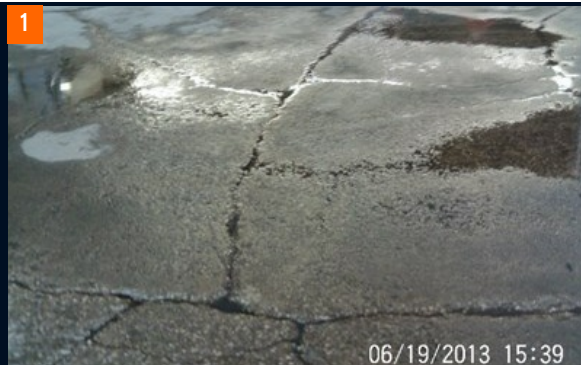
Cracks and pitting caused by studded tyres of a Zamboni.

1. Prior to application
2. Surface preparation in progress
3. Application in progress
4. Completed application
