# BELZONA REPAIRS HOLE IN PROCESS KETTLE

ID: 5839

Process kettle at a food production plant.

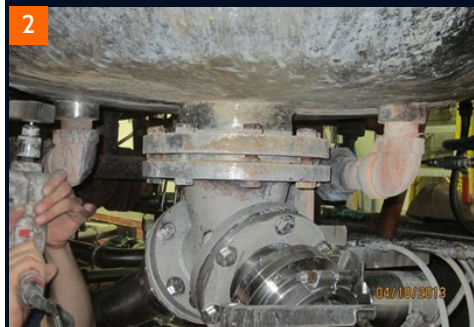
A hole in the weld seam due to corrosion.

1. Prior to application
2. Surface preparation in process
3. Completed application
4. Completed application

The application was carried out in accordance with Belzona Know-How System Leaflet VPF-1 for rebuilding erosion-corrosion damage. The surface was prepared by using a hand grinder. Belzona 9111 was used to remove all of the dirt and grease from the surface. A layer of Belzona 1511 was applied to the area and Belzona 9341 was wrapped over the layer. Then, Belzona 1511 was applied once again in accordance with the Belzona Instructions For Use.
