# BELZONA PREVENTS CORROSION DAMAGE TO 18' RISER

ID: 5840

18' riser on an offshore platform.

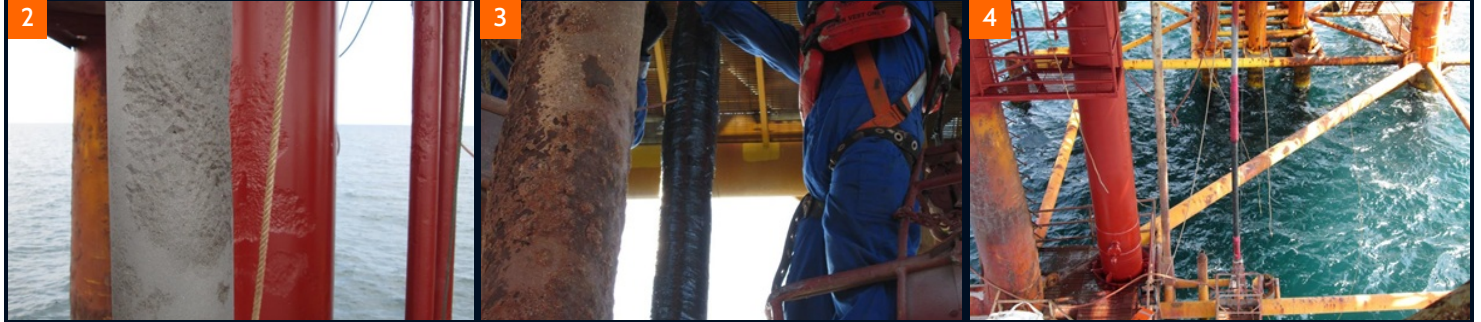
Corrosion damage to riser.

1. View of 18' riser prior to repair
2. Surface preparation
3. Application of Belzona 1982 complete
4. View of repair with Belzona 9382 wrapped over SuperWrap II during cure

The surface was blasted to the requirements of SSPC SP10 (Near White Metal). Profile measurements were checked and the surface was cleaned and degreased with Belzona 9111. Belzona 1121 was then applied to 18' of the riser to fill pitting in order to restore the original pipe thickness. Belzona 1121 was sanded to abrade the surface and wiped down with Belzona 9111. Belzona 1982 was applied in 5 layers. Belzona 9382 was wrapped over the Superwrap II application area to consolidate and compress during cure.

The repair and application of Belzona SuperWrap II was completed in less than 8 hours, in addition to the 24 hours required for the system to cure. Belzona had quality control throughout the application and all hold points surveyed were registered.
