# BELZONA PROVES TO BE THE RIGHT CHOICE FOR FLANGE PROTECTION

ID: 5841

Flange on an offshore platform.

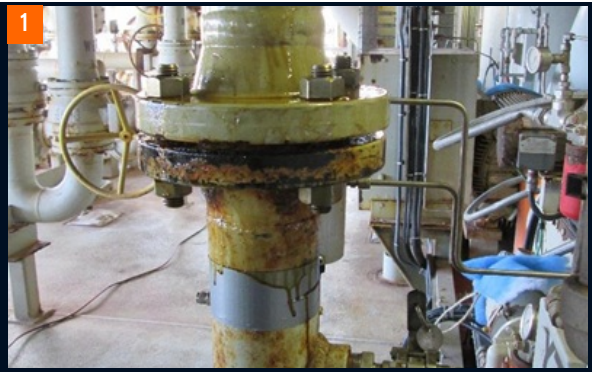
1. After surface preparation, Belzona 8411 was applied to the flange
2. Substrate ready for application with bolt covers and bridging tape
3. Application of base coat of Belzona 3411
4. Application completed with second coat of Belzona 3411

Corrosion around the flanges and bolts resulted in serious damage. The customer was looking for a practical and efficient solution to this problem. Several manufacturers were considered for the task including Belzona. Application was to be completed in situ and inspected after 6 months.

The application was carried out in accordance with Belzona Know-How System Leaflet GSS-11.
