# BELZONA 1291/1212 REPAIRS PUMP UNDER PRESSURE

ID: 5843

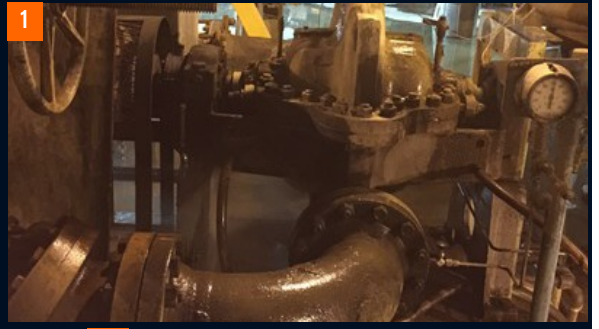
1. View of pump operating at 200 psi visible on the gauge.
2. Actual leak.
3. Valves were shut off and leak was slowed down to complete the repair.
4. Completed repair and in service with Belzona 1291 and Belzona 1212. The pump was slowly brought back up to full pressure to assure the leak was fixed.

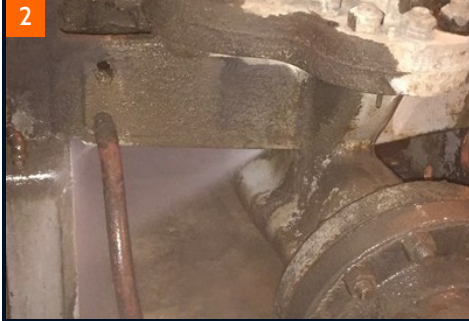
The customer had a 200 psi high pressure raw water pump casing that was leaking. This pump could only be out of service for a small amount of time.

The surface preparation was carried out with a scraper to remove the layers of paint. Then, a coarse file was used to etch around the hole and an MBX bristle blaster was used to prepare the surface. Bonding a plate was not an option due to the location of the hole being below where the casing was bolted together. Belzona 1291 was used to stop the active leak and Belzona 1212 was used to add thickness back to the pump casing that was saturated with water.
