# BELZONA REPAIRS FLANGE OF OFFSHORE PLATFORM

An offshore platform was experiencing a leak in a nozzle flanged connection on a Deaerator Tower. The corrosion was related to high concentration of an oxygen scavenger chemical.

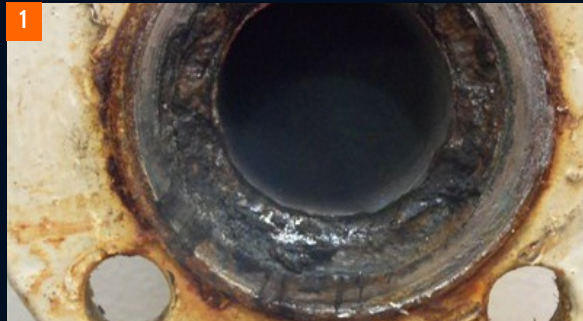
1. Original condition
2. Ready for bolting together
3. Flange former in place
4. Completed application

This flange face forming repair was conducted in accordance with Belzona Know-How System Leaflet VPF-17 for forming raised flange faces with Belzona flange face forming kit. The former was prepared and treated with two coats of Belzona 9411 for further releasing purposes. The damaged face was manually prepared and cleaned with Belzona 9111. Belzona 1111 was chosen as the rebuilding material and applied onto both the former and the damaged flange face. Both surfaces were brought together, levelled, and Belzona 1111 was allowed to cure. Upon completion of the curing time, the former was dismantled and the repair was visually inspected for any sharp edges, dips, or raises. The application was completed.
