# BELZONA REPAIRS CRUSHER SHAFT

ID: 5847

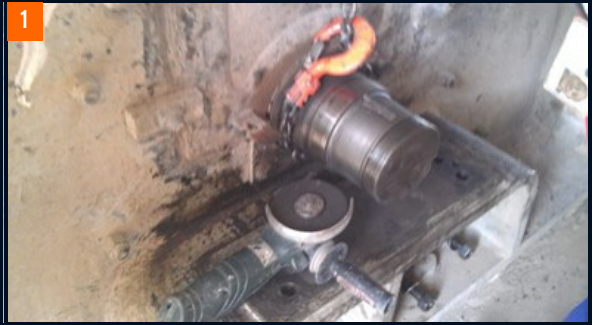
The hammer crusher shaft was worn on the taper bearing location.

1. Shaft being prepared. 2. Roughened shaft being degreased with Belzona 9111. 3. Belzona 1111 applied to shaft before former located. 4. New bearing installed on the shaft.

Application was carried out in accordance with Belzona System Leaflet MPT-2. A former was used to accurately rebuild bearing location on the shaft.
