# COURTHOUSE PLAZA STAIRS REPAIRED WITH BELZONA

ID: 5849

County Courthouse, Vermont, USA

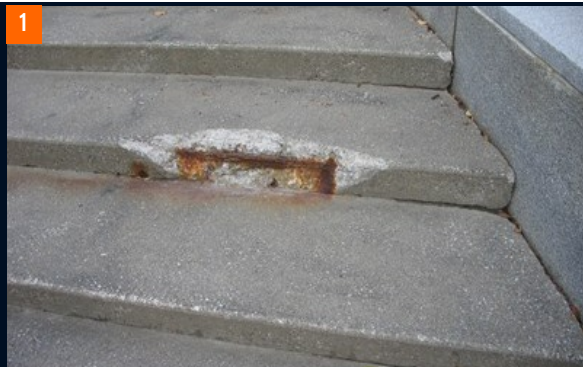
Main entryway plaza steps from the street and into the courthouse had several unsightly spalls and cracks in the concrete caused by winter freeze thaw and use of chemical deicers.

1. View of damaged step
2. Other visible damages to steps
3. Completed repair
4. Overview of completed repair

The application was carried out in accordance with Belzona Know-How System Leaflet FPA-5. The surface was prepared by hand cleaning with power tools.
