# BELZONA REPAIRS CORRODED PIPEWORK ON METHANE TANK

ID: 585

Pipework for collection of the gases on tank top cover

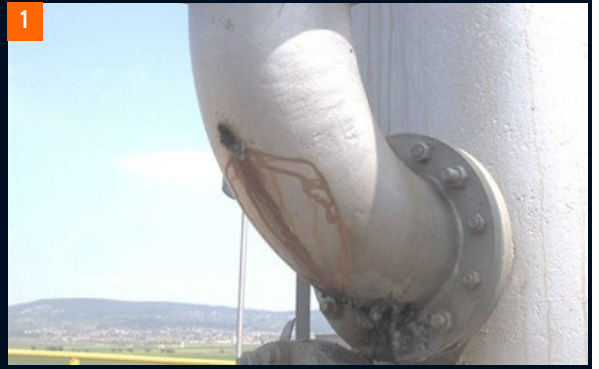
Corroded area and leaking hole on the Methane pipework.

1. Damaged areas preview
2. Belzona 4301 applied with reinforcement plates
3. Belzona 3121 applied over the corroded areas
