# BELZONA REPAIRS DAMAGED FLOORS CAUSED BY DRIPPING PROBLEM AT UNIVERSITY

ID: 5850

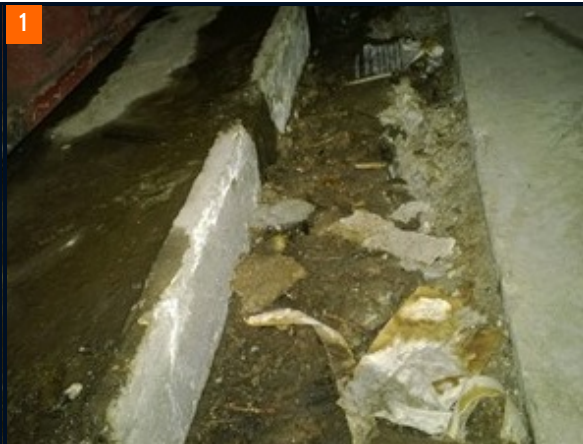
A sweating air conditioner system dripped water onto a mechanical room floor and eventually found the cracks in the classrooms below. High humidity in summer caused condensation on an AC system, which had been recently upgraded. The system was in an area where a building expansion had occurred and a large trough had never been repaired. Additionally, the old building floor and the new building floor were not levelled or of similar construction materials.

1. View of the problem with water dripping on the floor
2. The different floor levels and substrates
3. Cleaned by hand tools (grinder)
4. Applying the product by hand
