# BELZONA PROVIDES GREAT RETURN ON INVESTMENT

ID: 587

Air handler shaft

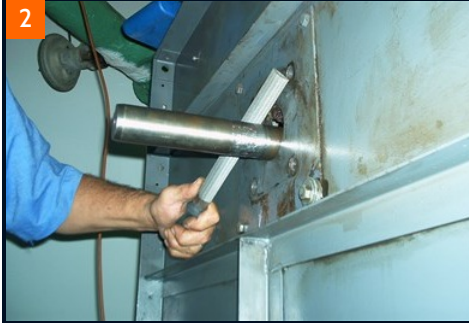
Worn shaft caused air handler to not operate effectively.

1. Worn area of air handler shaft
2. Surface preparation in-situ
3. Cured Belzona 1111
4. Air handler back in service
