# BELZONA REPAIRS TURBO SEPARATOR AT PAPERMILL

ID: 5872

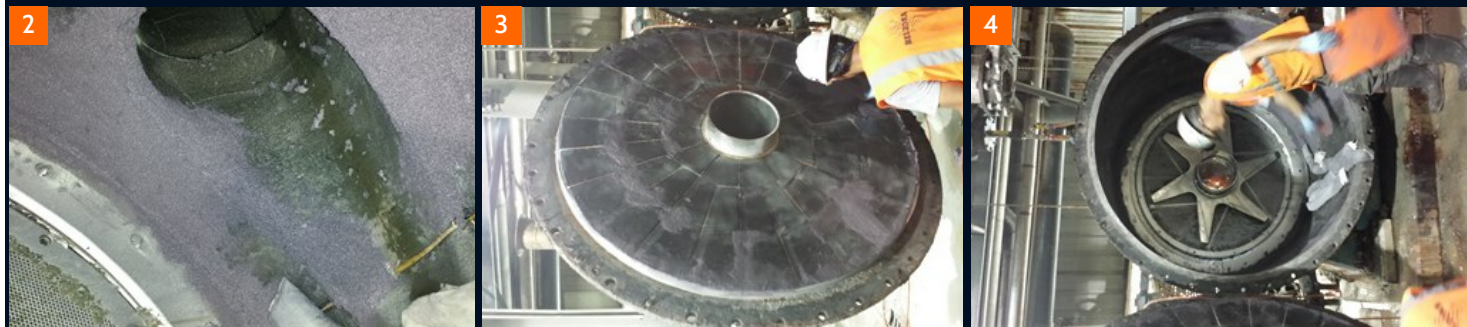
## PHOTOS

Extreme abrasion producing a hole through ceramic tile and steel causing a possible shutdown.

1. Hole in tile and steel.
2. Repair to hole with Belzona 1811.
3. Repair to other areas of separator.
4. View of separator.

The application was carried out with a modified version of Belzona Know-How System Leaflet CEP-6. The job timeline was critical. For surface preparation, the areas were aggregate blasted. Belzona 1811 was applied with a backer plate over the hole. Belzona 1811 was then applied over other worn areas. The vessel was force cured for start up.
