# BELZONA REPAIRS TURBO SEPARATOR AT PAPER MILL

ID: 5873

40 year old separator at recycling paper mill.

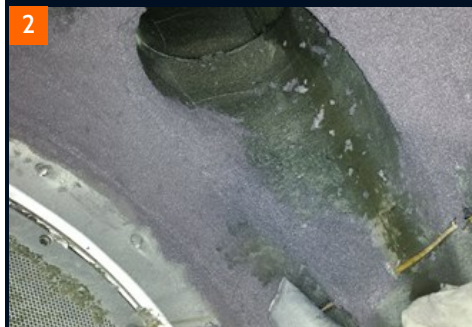
Extreme abrasion producing a hole through ceramic tile and steel, causing a possible shutdown.

1. Hole in tile and steel
2. Hole repaired with Belzona 1811
3. Repair to other areas of separator
4. Overview of separator

The application timeline was critical. The application area was prepared through aggregate blast. Belzona 1811 was applied with a backer plate over the hole. Belzona 1811 was applied over other worn areas. Vessel was forced cured for start up.
