# BELZONA REPAIR TO KING PIN BUSH HOUSING

ID: 588

Front end loader king pin connection

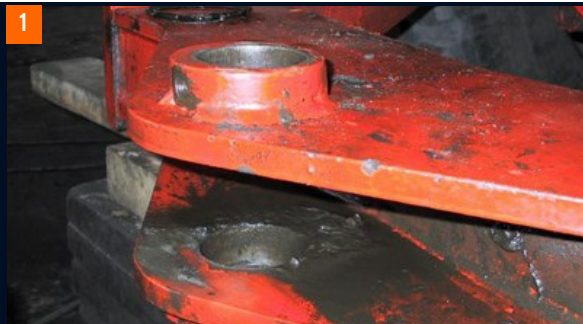
Wear of the seats leading to increased clearance

1. View of the damaged connection.
2. Belzona 1111 applied on the prepared housing surface.
3. The pin coated with release agent was used to form the housing.
