# BELZONA SEALS VALLEY GUTTERS

ID: 5887

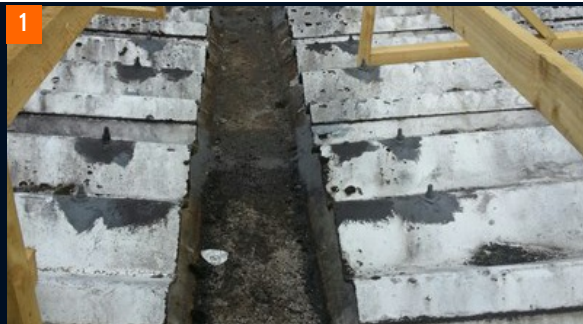
Several valley gutters constructed from cast steel had begun to leak from the joints. These leaks were causing damage to the stored materials below.

1. Length of gutters before surface preparation
2. Section of gutter showing build up of dirt & corrosion
3. Length of gutter coated
4. Standing water still an issue but the gutter is now leak free
