# TIRE REPAIR WITH BELZONA ELASTOMER

ID: 589

Rear tire of front end loader.

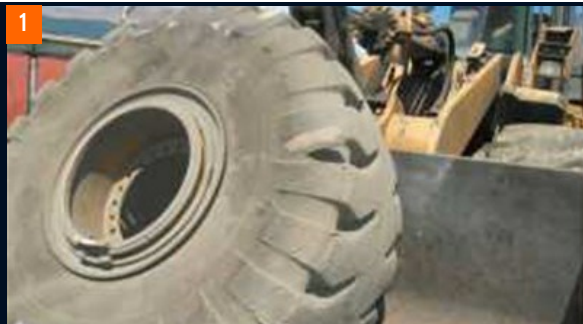
1. Size of the tire clearly evident
2. The metal alongside and the damage it caused
3. Prepared and conditioned area
4. Finished Elastomer repair

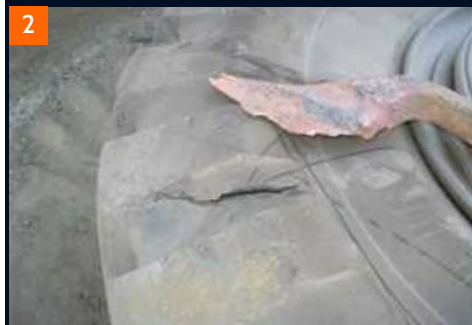
A piece of metal penetrated the sidewall.
