# BELZONA REPAIRS TANK NOZZLE

ID: 5892

400,000 sulfuric acid holding tank nozzle.

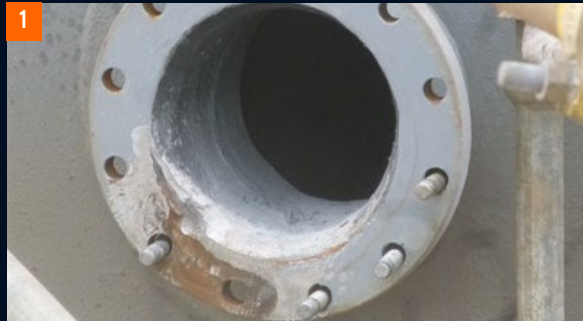
The original coating inside the tank nozzle failed due to acid erosion. Sulfuric acid began leaking into the containment area.

1. Damaged tank nozzle
2. Blast work being carried out on tank nozzle
3. Rebuilding the flange of the nozzle with Belzona 4301
4. Completed nozzle with Belzona 4311 coating
