# REPAIRING COOLING TOWER SEAMS WITH BELZONA

ID: 5896

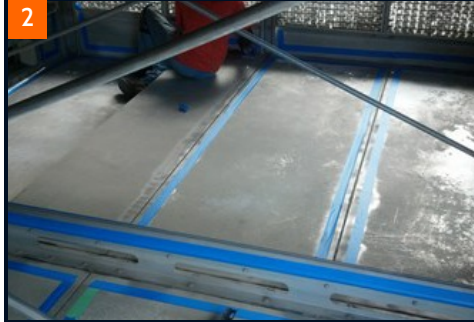
1. Blasting completed, prior to media removal
2. Taping and conditioning all seams/protrusions
3. First coat of Belzona 2131, embedding Belzona 9341
4. Completed application to towers

The application was carried out in accordance with Belzona Know-How System Leaflets HEX-6, HEX-13, TCC-12, FPA-6 and a modified version of FPA-7. The substrate was prepared via media blast with Black Beauty, cleaned, taped, and then conditioned with Belzona 2911. Once cured for ½ hour, a two-coat reinforced system of Belzona 2131 was utilized to create a polymer overlay over all assembly seams/joint. Bolt holes and other protrusions were top-dressed with a coating of Belzona 2131.
