# BELZONA AIRTIGHT CONTROL ROOM

ID: 59

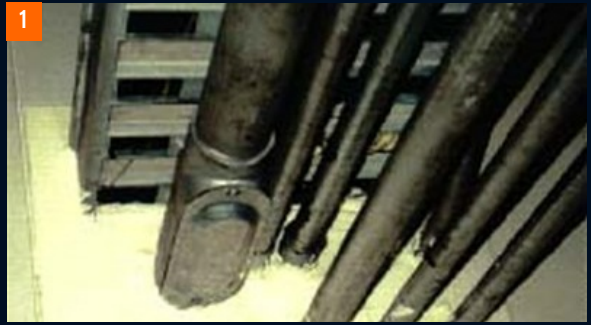
1. All entry points made airtight with Belzona 3211.
2. Doorways of the building sealed.
3. Belzona 2211 used to seal where the metal wall meets the floor.
