# SHAFT JOURNAL OF STONE CRUSHER REPAIRED WITH BELZONA

ID: 590

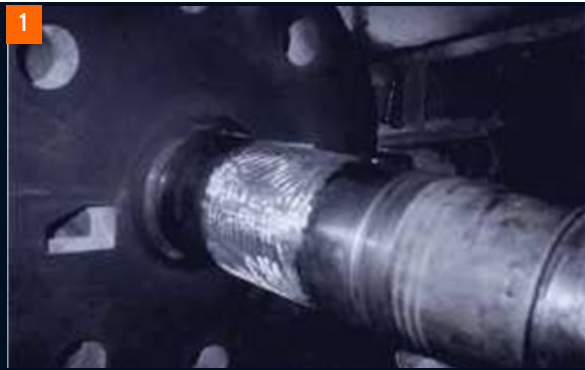
Shaft damaged by seized bearing.

1. Preparing shaft surface
2. Forming with manufactured pipe clamp
3. View of repair with former removed

Application was carried out in accordance with Belzona Know-How System Leaflet MPT-2.

Belzona 1321 (Ceramic S-Metal)  
Belzona 9411 (Release Agent)
