# BELZONA PROTECTS TUNNEL AGAINST EROSION

ID: 5905

Spawning tunnel of 50 meters in length and 6 meters in diameter.

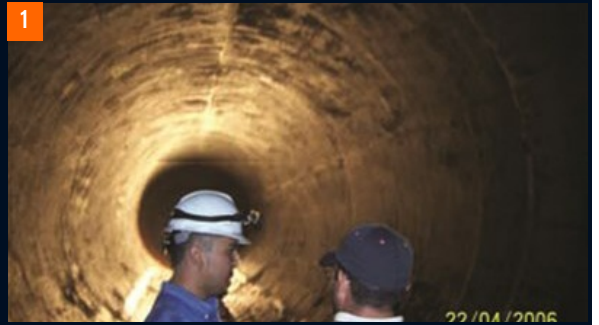
The high flow damaged the tunnel's walls due to erosion and solutions with conventional concrete were unsuccessful in the past.

1. General view
2. Mortar application
3. Restored tunnel
4. Belzona 5811 application
