# BELZONA OFFERS PROTECTION TO NEW FLOATING HEAD

ID: 5908

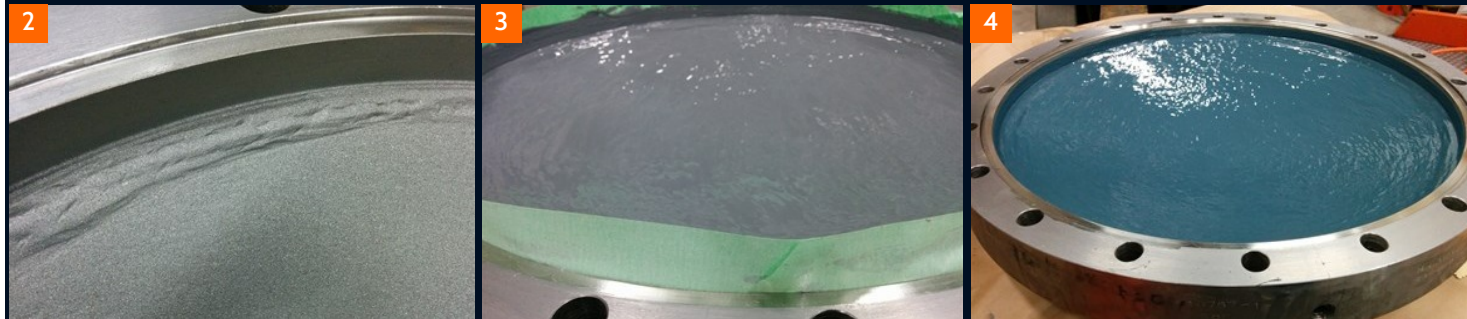
1. Surfaces abrasive blasted being masked prior to coating
2. Close up of abrasive blasted profile
3. Application of 1st coat of Belzona 1321 (Grey)
4. Completed application 2nd coat of Belzona 1321 (Blue)

The application was carried out in accordance with Belzona Know-How System Leaflet HEX-3 for erosion/corrosion resistance coatings. Masking tape was placed at the outer edge of the rebate grooves in order to highlight the area to be coated and to give a neat and clean finish. Then, the selected Belzona product was mixed and an even coat was applied at the specified thickness, using stiff short bristled brushes. Then, it was made sure that the coating was finished into the rebate grooves. Wet film thickness gauges were used to ensure the recommended film thickness was achieved. The masking tape was removed immediately. Allow to cure before applying a second coat, where specified, of the selected Belzona product, again ensuring that it is correctly finished within the rebate grooves.
