# BELZONA ENHANCES PUMP EFFICIENCY

ID: 591

General erosion/corrosion damage leading to reduced pump efficiency

Double end suction centrifugal water pump

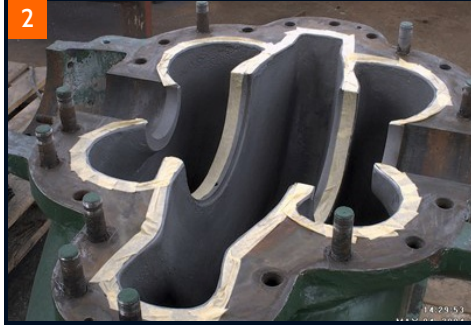
1. Surfaces before application
2. Preparation of the casing
3. Two coats of Belzona 1341 applied
4. Inspection view after a year in service

Application procedures were carried out in accordance with Belzona Know-How System Leaflets CEP-5 and CEP-10.

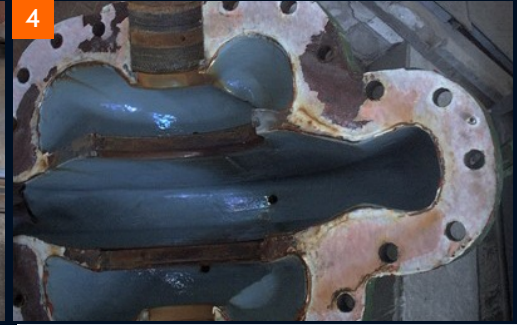
As a result of applied efficiency enhancement coating and further sealing rings seat repair, reduced power consumption was registered and efficiency increased by 9.91%. The inspection after 12 months in service shows the perfect condition of the applied coating.
