# BELZONA GIVES ABRASION RESISTANCE TO ELBOW

Worn pipe elbow

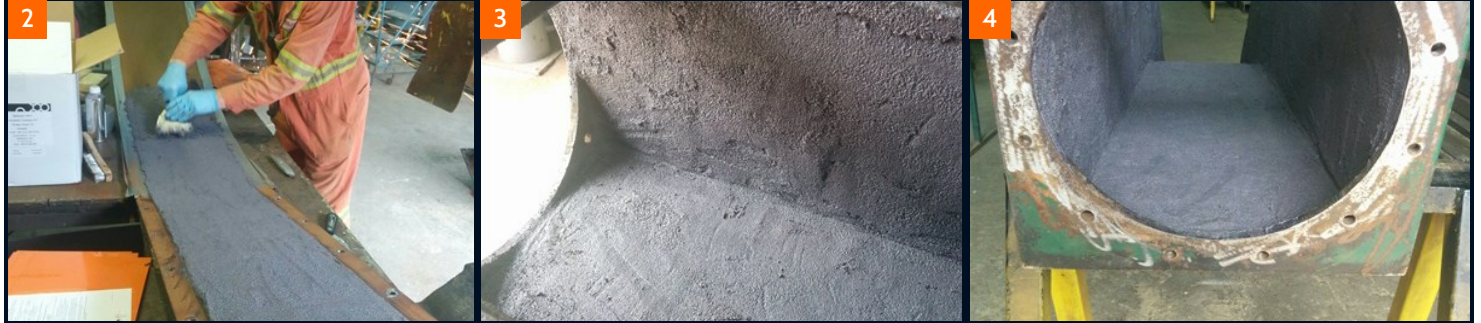
## PHOTOS

Blown wood particles create loss of wall thickness due to abrasion, eventually leading to blow-outs and loss of production.

1. General view of elbow
2. Application of Belzona 1812 to replaceable back
3. Close up of application of Belzona 1812 to elbow
4. Completed application

The application was carried out in accordance with Belzona Know-How System Leaflet SHM-8 for rebuilding worn pipe elbows. Belzona 1812 was selected as the appropriate Belzona material and applied to the wear areas of the elbow and the replaceable back, keeping within the designated wearing surface. The application was completed using a rigid applicator.
