# CONCRETE STEP REPAIR WITH BELZONA

ID: 5912

Concrete steps were broken and deteriorating.

Concrete steps leading up to the entrance of building.

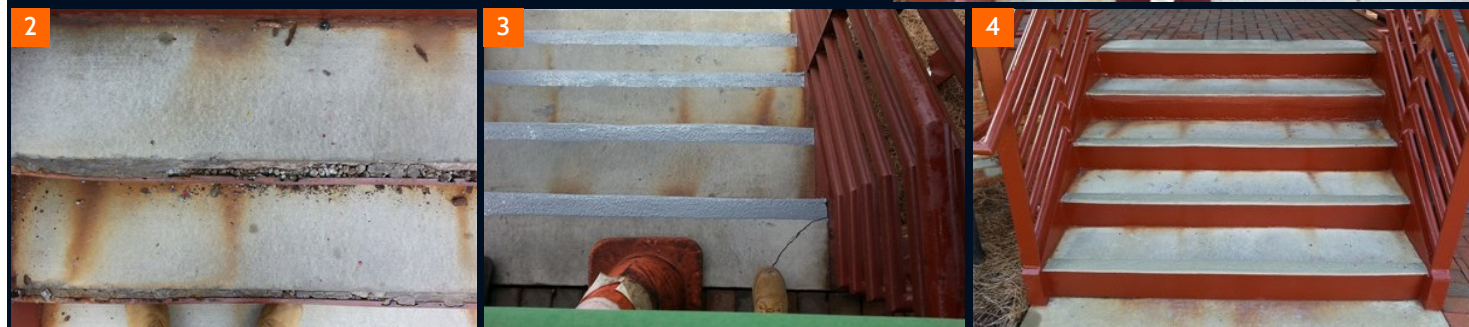
1. Prior to application
2. Preparing the surface by removing busted concrete
3. Application of Belzona 4411 with some aggregate
4. Completed application

The old concrete was removed so that Belzona 4111 could fill in the spots. After the steps were smoothed over, Belzona 4411 was added with some aggregate.
