# BELZONA REPAIRS FGD WET LIME SLURRY DISTRIBUTION BOXES

ID: 5914

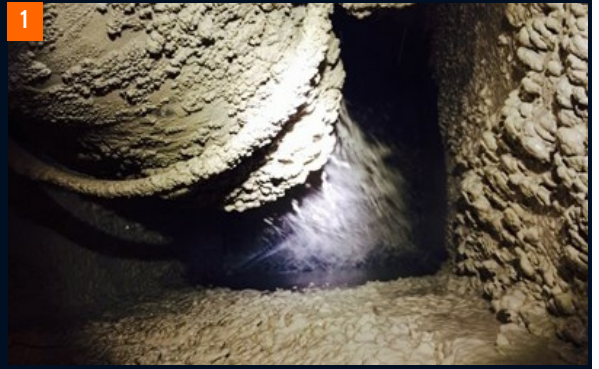
Distribution boxes are part of a wet FGD process involving wet lime slurry being dumped through a transfer hose that is moved between three chambers in one box.

1. Lime slurry being poured into the box
2. Distribution box had been laid on its side for the application to start with welded plate covering one hole visible in the cyclone area
3. Belzona 9811 being installed on top of a wet layer of Belzona 2111
4. Belzona 1812 being installed as a grout and void filler

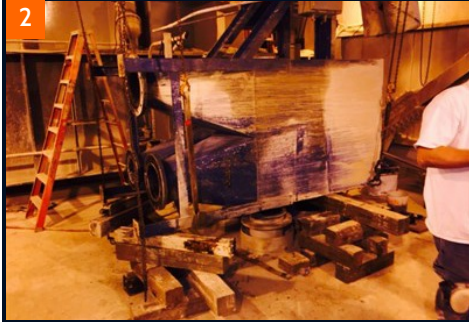
Lime slurry had worn away the existing rubber liner through the steel, and had created holes and washed out areas towards the bottom of the boxes in the cyclone areas.

The application was carried out in accordance with Belzona Know-How System Leaflet SHM-7. Surface preparation was done by using a MBX bristle blaster and Belzona roughing brushes. Belzona 1121 was used to seal all holes and rebuild the metal substrate back to its original thickness. Then, Belzona 2911 was used to condition the surface. Belzona 2111 was applied to rebuild worn rubber areas and it was also used as a bonding agent for Belzona 9811. A layer of Belzona 9811 wear tiles was embedded into Belzona 2111 to help absorb the impact behind the tiles. Belzona 1812 was then used as a grout and to fill/seal any voids.
