# BELZONA REPAIRS IRRIGATION HOSE

ID: 5916

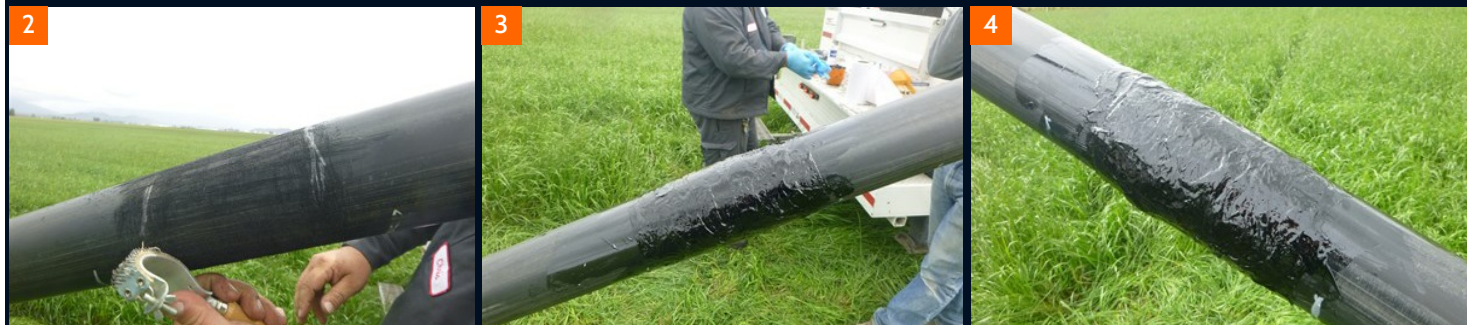
A small crack formed from hose working on and off the reel.

1. Hose lifted to a working height.
2. Roughing brush used to obtain a rough surface profile.
3. Belzona 2111 with Belzona 9341 applied over the conditioner.
4. Completed application.

The pipe was lifted to working height for preparation and application. Then, the pipe was scuffed with a roughing brush for 2 inches on both sides of the crack. The pipe was conditioned before applying a layer of gelled Belzona 2111, followed by Belzona 9341 and an overcoat of Belzona 2111.
