# BELZONA PROTECTS SLUDGE PUMP

ID: 592

Casing of a sludge pump

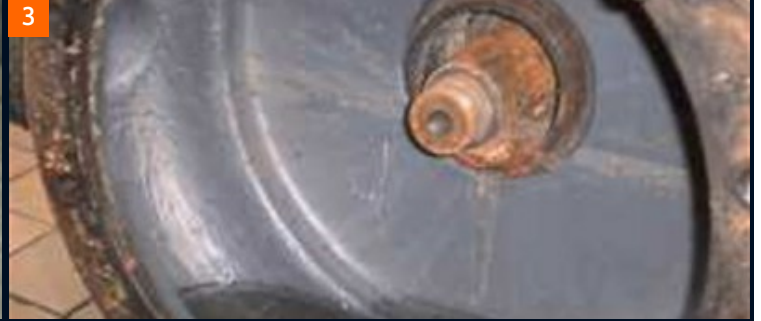
Pump suffered very low efficiency and was considered to be scrapped. Belzona was chosen both on basis of cost and fast turn-round. Inspection after 600 working hours showed the pump casing was still in excellent condition.

1. Worn out pump casing.
2. After Belzona 1321 application.
3. Inspection view 600 working hours after application.
