# BELZONA REPAIRS COPPER PIPE

A leak in a copper return line coming from a 1500 gallon glycol tank at the Micro Brewery.

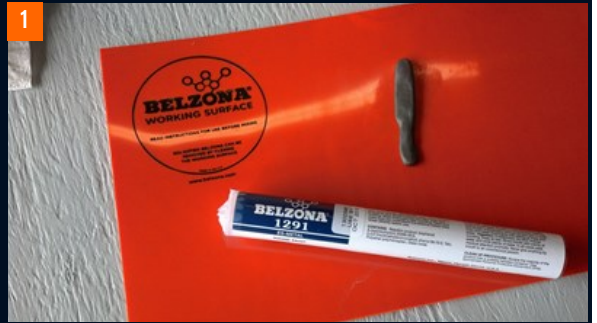
1. Prepared worm of Belzona 9611
2. Tourniquet applied
3. Application of Belzona 1212 with Belzona 9341
4. Completed application

The application was carried out in accordance with the modified of Belzona Know-How System Leaflet VPF-11. A worm of Belzona 9611 was applied to the leaking pipe. The tourniquet from the Belzona 9611 kit was applied and left overnight. The tourniquet was removed the next day and the surface was prepared further with acetone and heat. The final step was applying Belzona 1212 with Belzona 9341.
