# BELZONA 7111 PROVIDES ALIGNMENT TO MAIN ENGINE ON BOAT

ID: 5921

Main engine base of the propulsion system on the fishing boat.

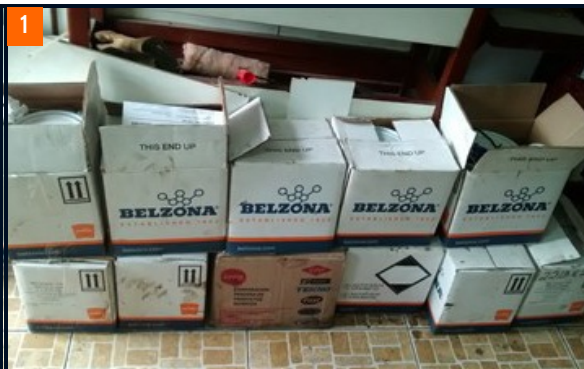
1. Belzona 7111 on board
2. Chock at engine base
3. Detail of curing before pouring
4. Verifying the correct engine-gearbox alignment

After pouring Belzona 7111 in four chock casings and curing, the alignment was verified within the acceptable and projected range. The process of pouring the liquid polymer offers benefits while replacing the manufacturing of metal shims that do not guarantee 100% support, are costly, needs time and corrections, which requires more days of downtime with no production and would result in a great loss in costs. Belzona 7111 has certification of Marine Classification of Lloyd's Register and American Bureau of Shipping.
