# BELZONA REPAIRS BROKEN FLANGE

ID: 5922

Semi-fine limestone material transfer pipeline system.

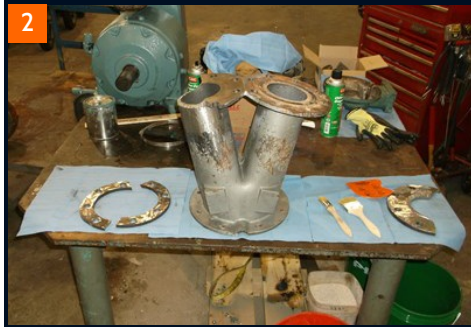
Broken flange collar was causing material to spill out when in operation.

1. View of the broken flange and removing paint to prepare surface
2. Broken flange in the center, broken piece to the right and the steel backers to the left, ready for the application
3. Side view of completed flange repair
4. Top view of completed flange repair

A 2-piece steel backer was built to bond to the broken flange for added strength. A grinder was used to roughen the application surface. It was then thoroughly cleaned and Belzona 9411 was applied to the bolts, washers, and nuts. A part of Belzona 9341 was pre-cut. A thin coat of Belzona 1111 was applied to all application surfaces and onto Belzona 9341. The application started by wrapping Belzona 9341 around the shoulder of the flange and then the broken piece was mounted back onto the flange using the steel backers. For a finished fit, the bolts were tightened down. Then, the remainder of Belzona 1111 was applied over Belzona 9341.
