# STRIPPED THREADS QUICKLY REPAIRED WITH BELZONA

ID: 5928

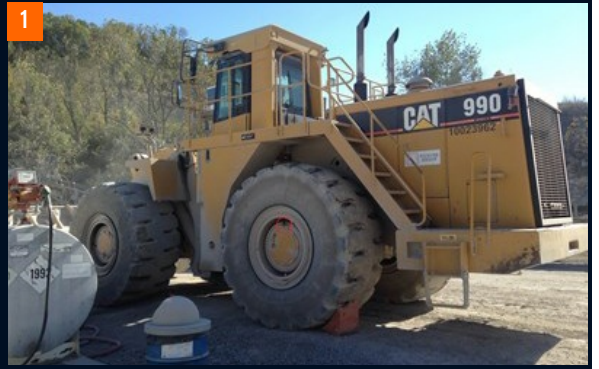
The oil plug on a Caterpillar 990 Final Drive, had been stripped when someone used an impact wrench instead of hand tightening the bolt. The customer was faced with downtime of the equipment and expensive new parts.

Stripped threads on a Caterpillar 990 Final Drive were leaking oil.

1. Cat 990 with leaking oil evident
2. Bolt cavity prepared for application
3. Applying Belzona 1212 to threads on bolt and bolt cavity
4. Completed application, bolt snugged down and waiting to go back into service
