# BEARING HOUSING REPAIR WITH BELZONA

Centrifugal pump bearing housing

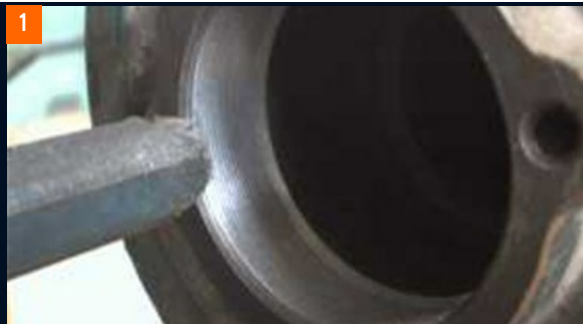
Housing damage after bearing seized leading to increased clearance.

1. Preparing surface
2. Belzona 1111 applied
3. Housing with restored dimensions after machining

Application was carried out in accordance with Belzona Know-How System Leaflet MPT-6.
