# BELZONA 7111 PROVIDES CHOCKING TO DRIVE SYSTEM ON FISHING BOAT

ID: 5933

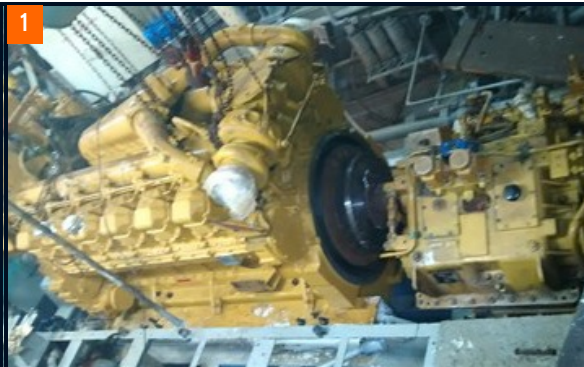
1. View of the engine and machine room
2. Inspection of the box and engine chocks
3. Completing work on the engine chocks
4. Adjusting bolts with torque wrench for precision.

The four chocks for the engine and two for the box were carried out by pouring Belzona 7111 which has American Bureau of Shipping certification. Once the product cured completely, it underwent compression with weight and adjustment of anchor bolts maintaining the specified parameters of alignment. It has been proven that Belzona 7111 has a lower cost than other chocking materials.
