# PROVEN BELZONA REPAIR AND PROTECTION OF FLOOR PROBLEM AREAS

ID: 5934

Metal tread on concrete steps

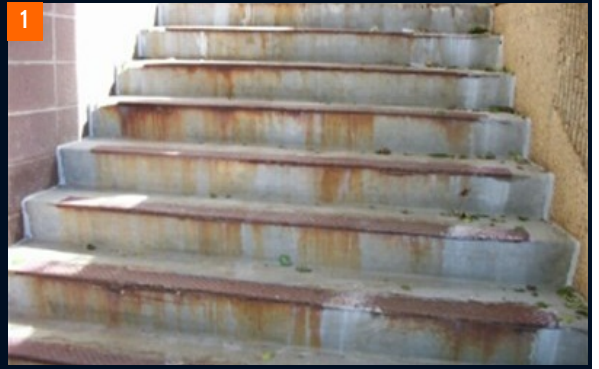
The metal treads on these stairs had come loose due to severe spalling around the fasteners. The corrosion of the treads had stained the risers and created an unsightly appearance. The conventional solution was a costly tear-out and replacement.

1. Overview damage of treads on concrete steps 2. Damage to the concrete 3. Completed application 4. Inspection after 12 years shows steps to be in perfect condition

The application was carried out by the in-house crew with Belzona technical training. Lap siding was attached to the risers to use as formers and Belzona 4131 was applied to completely resurface the steps.
