# BELZONA STOPS HIGH VOLTAGE CIRCUIT BREAKER LEAK

ID: 5935

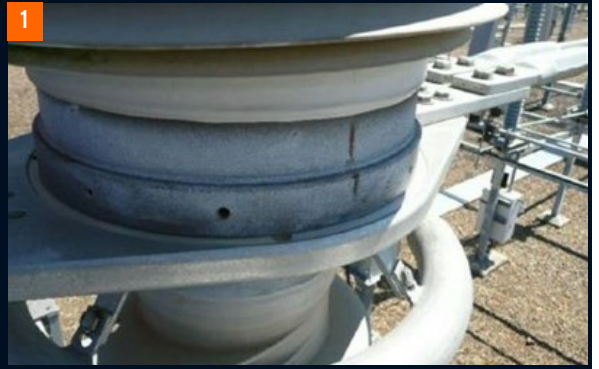
With a broken seal, SF6 gas was leaking into the environment. SF6 is potent greenhouse gas and subject to strict environmental control.

An aging circuit breaker seal had failed.

1. Damaged Circuit Breaker 2. Surface Preparation underway 3. Application of Belzona 1212 wrap being carried out. 4. Completed Application
