# BELZONA REPAIRS AND PROTECTS CORRODED EXHIBITION SUPPORTS

ID: 5936

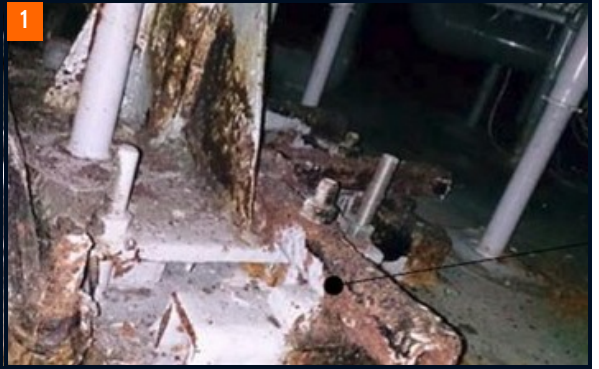
During the life of the exhibition, the metal support structure underneath the exhibition was heavily corroded by the oxidising nature of the Bromine Water. The museum were concerned about the corrosion and thus the decreasing strength of the supports.

1. Supports before application
2. Supports before application
3. Application of 5811 underway
4. Finished application showing close colour match achieved with Belzona 5111

Application was carried out in accordance with Belzona System Leaflet TCC-5. The corroded metal structure was blasted back to bare metal using sponge blasting as the client was concerned about the dust created by using regular grit blasting. Areas that were especially corroded and damaged were rebuilt using Belzona 1111. Belzona 5811 was applied with a top coat of Belzona 5111 to protect against oxidation and provide a good colour match.
