# BELZONA TIRE REPAIR QUICKLY GETS LOADER BACK IN SERVICE

ID: 5937

Repair of the tire sidewall on a front end loader.

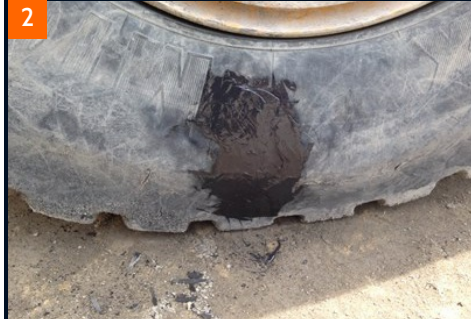
A large crack approximately 10 inches long and up to 2 inches deep had developed. There was no spare tire and removing it for vulcanization would leave the operation short of their only loader. This loader was used to supply materials for the entire block plant and without it, the entire operation is down. The deep crack was exposing radial belting and needed something to stop the moisture from attacking the steel radials and keep the crack from running further.

1. Crack cleaned, roughened, and conditioned.
2. Application of Belzona 2311.
3. Two weeks later, material which had exceeded the conditioned area had peeled and need to be trimmed off (always tape off your edges!).
4. Repair revisited 3 Months after application, Belzona still perfectly adhered.

The application was carried out in accordance with Belzona Know-How System Leaflet SHM-15. The area to be treated was cleaned with a cleaner/degreaser and then abraded using a wire wheel, Belzona roughing brush and rotary tool. After a final cleaning the area was treated with Belzona 2911 and allowed to dry for 30 minutes. Belzona 2311 was then used to coat the radials and rebuild the profile of the tire. The entire application was completed and the loader was back in service in less than two hours.

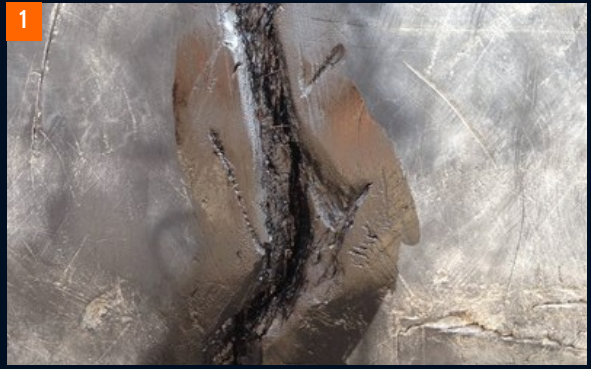
Due to downtime concerns, the loader could not be taken out of service for more than a few hours. A new tire was over \$4,000.00 and as long as the crack could be repaired this tire still had a lot of service life remaining. Belzona materials cost the customer less than \$75.00. The hoppers which fed the plant were filled before the repair was started and the repair was completed and cured before the hoppers needed to be refilled, costing them no downtime. This repair was revisited 3 months later and is still performing perfectly.
