# BELZONA SAVES WASTEWATER PLANT SIGNIFICANT REPLACEMENT COST

ID: 594

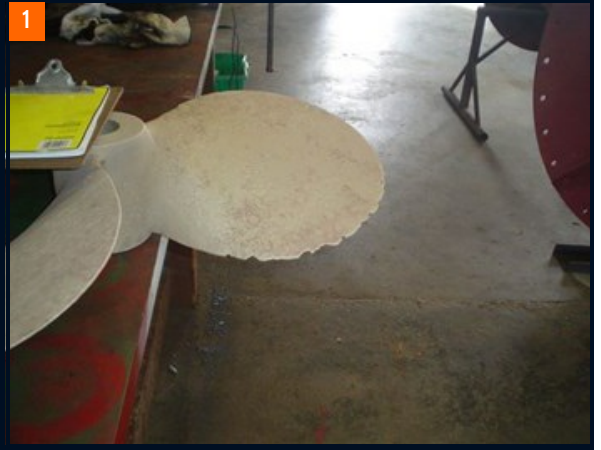
Worn edges caused propeller to be in-efficient. Client was going to replace with new equipment.

1. Propeller blasted
2. Belzona 1311 and 1321 being applied
3. First coat of Belzona 1321 complete
4. Completed application

Application was carried out in accordance with a modified version of Belzona Know-How System Leaflet CEP-1.
