# BELZONA PIPE REPAIR KEEPS COOLING TOWER IN SERVICE

ID: 5940

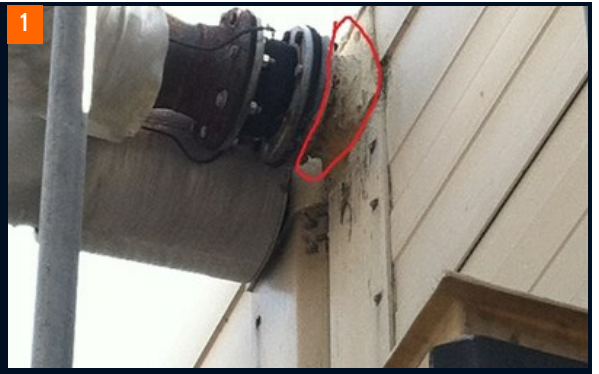
The water inlet on a cooling tower had developed a spiral crack due to the inflexible nature of the pipe and the movement of the cooling tower. It was leaking so badly that while the pumps were running, it would spray a stream of water over the side of the building onto walkways below.

1. Remnants of previous attempts to repair the pipe externally
2. Remnants of previous repair attempts inside the pipe
3. Pipe and crack cleaned, roughened and ready for the Belzona application
4. Repair completed, crack sealed with Belzona 1161 and an additional two coats of Belzona 1321

The application was carried out in accordance with a combination of Belzona Know-How System Leaflets VPF-8 and VPF-11. A flexible joint was removed next to the leak to allow the repair to be conducted from the inside of the pipe. Materials used in a previous attempt to stop the leak were removed and the inside of the pipe was thoroughly cleaned and abraded using a rotary tool and an oscillating tool. The crack was then v-ed out. Belzona 1161 was applied through the crack and two coats of Belzona 1321 were applied over this and for 6 inches in each direction from the repair for wear and erosion protection.
