# BELZONA SUPERWRAP II MEETS GAS PIPELINE OPERATOR REQUIREMENTS

ID: 5954

20" Gas Pipeline Riser on Offshore Production Platform

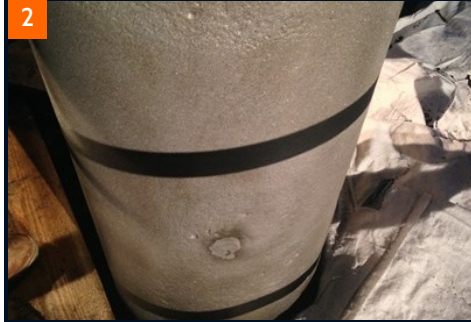
External corrosion led to a through-wall defect causing the platform to be temporarily shut down. The operator required a permanent repair compliant with DOT Standards. Traditional repairs required fabrication, causing extended downtime and production loss.

1. Riser with defects indicated.
2. Belzona 1291 plug and surface profile after blast.
3. Skim coat of Belzona 1161 for pit filling and leveling surface.
4. Completed SuperWrap II application, 4 wrap (8 layers) system.
