# BELZONA BONDS CABLE TRAY ON FPSO

ID: 5967

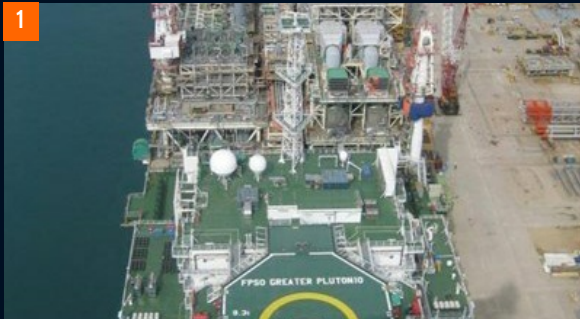
1. View of the vessel from above
2. View of the bonding application

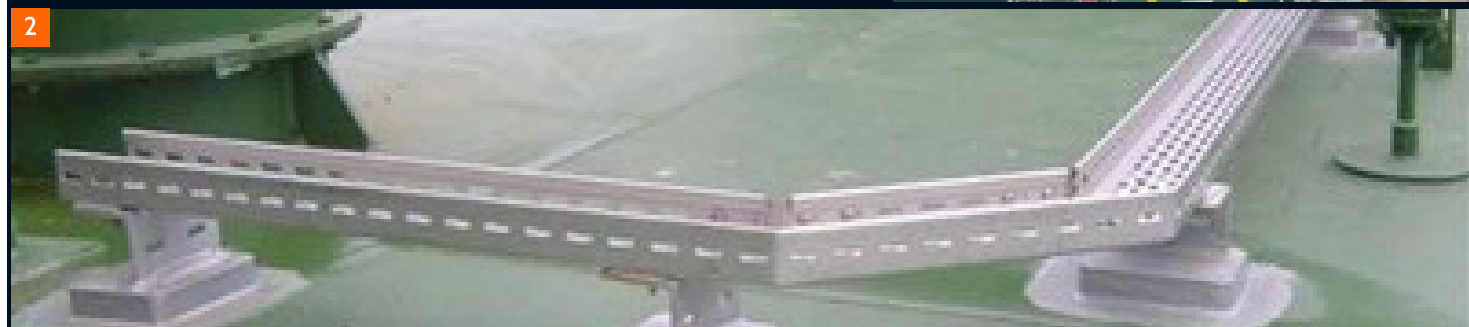
After the FPSO was painted, it was discovered that a cable tray had not been welded onto the deck. Welding would damage the paintwork, therefore Belzona was approached for a cold applied solution.

The application was carried out in accordance with a modified version of Belzona Know-How System Leaflet GSS-9.

In order to ensure that Belzona solution can be used for this application, a test has been performed mimicking expected in-service conditions. Result - test sample withstood 19.4kN of loading. Prequalification information and excellent vendor support have enabled the client to make the easy decision of using a Belzona solution. This bonding application has been in service with no issues since 2006.
