# BELZONA REPAIRS WASTEWATER PUMPS

ID: 598

Sulzer wastewater pumps (Five)

Large wastewater station, Egypt

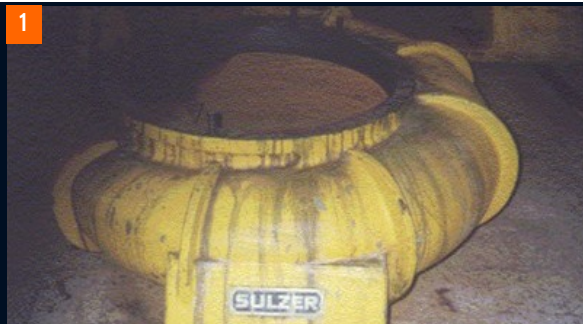
Corroded diffuser, casings and impellers leading to low efficiency of the pumps.

1. Corroded casings
2. Corroded diffuser
3. Diffuser was coated
4. Impeller coating completed
