# TOUGH AND LASTING BELZONA PROTECTION FOR PUMP IN DESULFURIZATION UNIT

Rubber coated pump cone in a desulfurization unit at a fossil power plant.

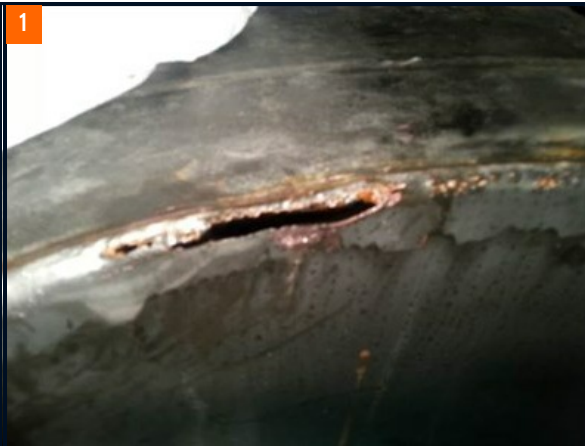
The cone was suffering from severe dry abrasion in the presence of strong concentrations of sulfides. Previously applied rubber coating started to peel, leading to leakages between flange couplings. Leaking corrosive substance in turn attacked the underlying metallic substrate, thus reducing the efficiency and the working life of this component.

1. Original holed rubber lining
2. Application of Belzona 1811
3. Application of Belzona 1811
4. Inspection after 1 year in service

The application was carried out in accordance with Belzona Know-How System Leaflet SHM-13. The failed rubber coating was removed, the substrate was then grit blasted and a thick layer of Belzona 1811 was applied to protect the cone from further abrasion damage.

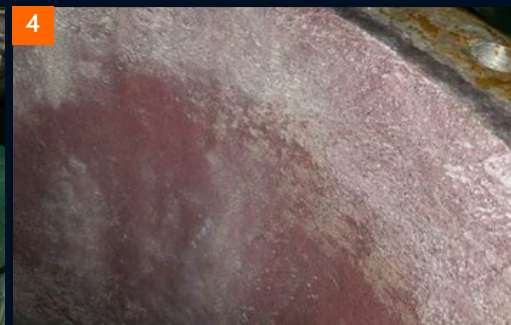
This Belzona solution succeeded where a competitive system had failed. After a year in service, Belzona 1811 is still in a as new condition, to the customer's delight. The Belzona solution effectively enhanced efficiency and the working life of this component.
